Alatech Home Inspection Service

Report Date
October 24, 2005

555 Hidden Oaks Dr.
Anywere, Al 33203

Project Information

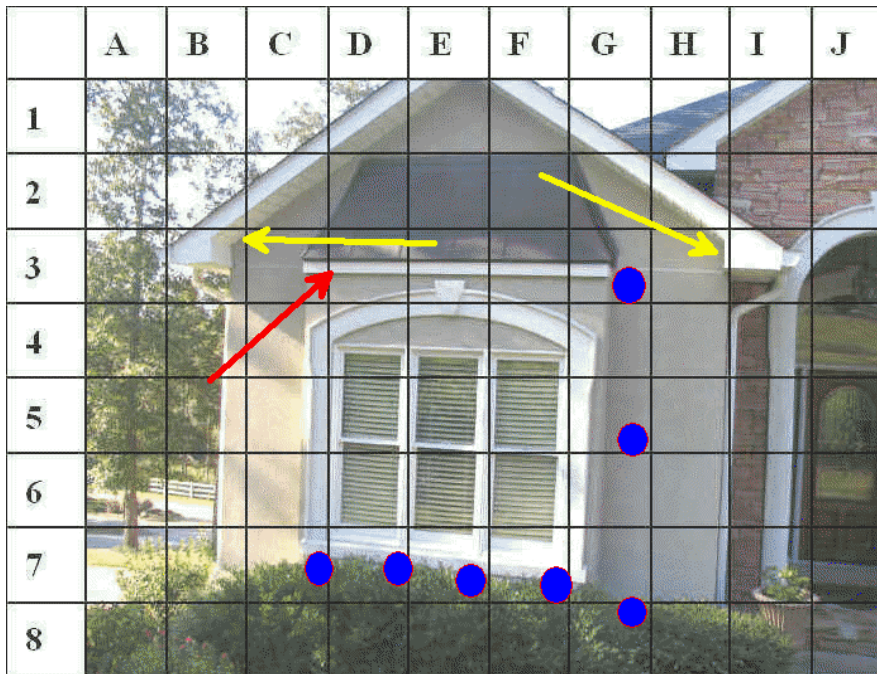
Grid Location	Item Description	Moisture Readings	Substrate Condition	Observations	Chapter Reference
D 3	Joint			Caulk joint where stucco meets dissimilar material or siding.	2, 4.2
C 7	Windows	9	Firm		
D 7	Windows	9	Firm		
E 7	Windows	7	Firm		
F 7	Windows	10	Firm		
G 3	Kickout	8	Firm		
G 5	Kickout	8	Firm		
G 8	Kickout	14	Firm		
B 3 H 3	Joint			Caulk joint where stucco meets dissimilar material or siding.	2, 4.2

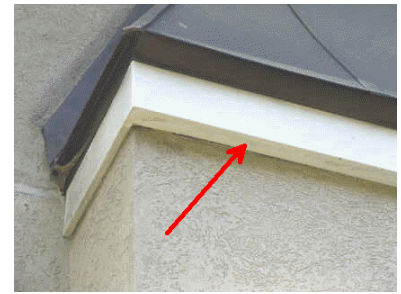
Joint not sealed.

Caulk or re-caulk any place below the soffit line where stucco meets another material. This may include utility penetrations, light fixtures, vents, downspout fasteners or other types of breaches to the stucco system.

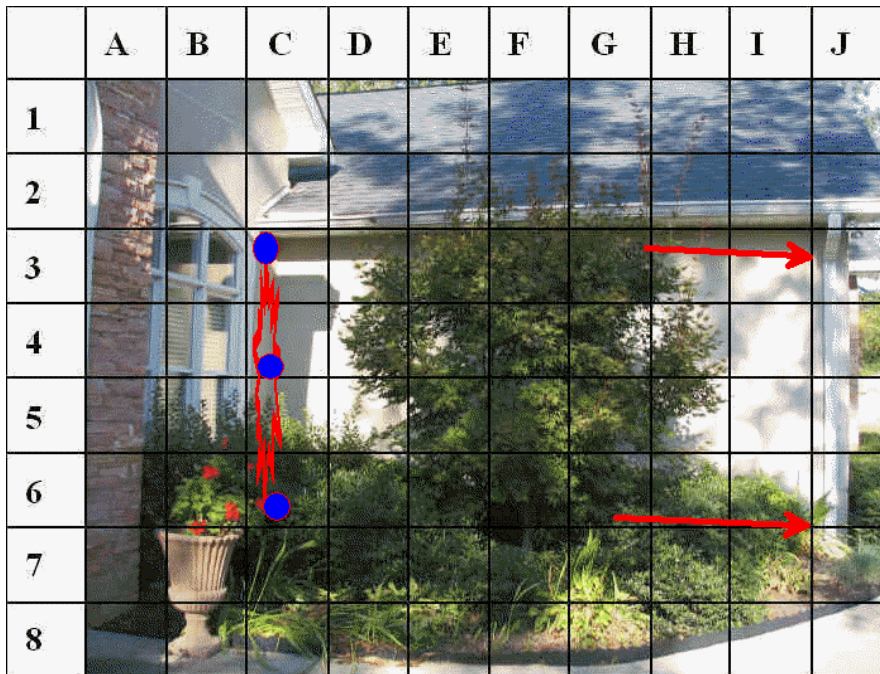
Grid Location	Item Description	Moisture Readings	Substrate Condition	Observations	Chapter Reference
C 3	Kickout	28	Soft	Kickout appears to be failing and needs to be modified or reworked. Elevated moisture found below kickout.	2, 4.3
C 4	Kickout	40	Soft	Elevated moisture reading below kickout.	2, 4.3
C 6	Kickout	23	Soft	Elevated moisture reading below kickout.	2, 4.3
J 3 6	Downspout			Downspout fasteners need to be caulked.

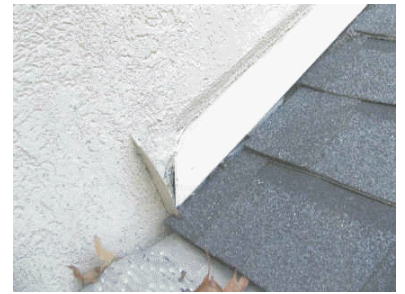
Kickout flashing failing.

Existing kickouts appear to be failing (elevated moisture found) and need to be modified. If kickouts were recently installed, the affected areas may not have had sufficient time to dry.
