Alatech Home Inspection Service

Report Date
October 24, 2005

555 Hidden Oaks Dr.
Anywere, Al 33203

Project Information

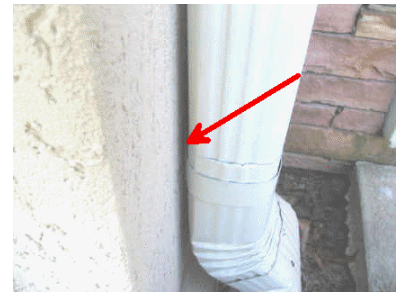
7

Kickout flashing failing.

Grid Location	Item Description	Moisture Readings	Substrate Condition	Observations	Chapter Reference
C 3	Kickout	28	Soft	Kickout appears to be failing and needs to be modified or reworked. Elevated moisture found below kickout.	2, 4.3
C 4	Kickout	40	Soft	Elevated moisture reading below kickout.	2, 4.3
C 6	Kickout	23	Soft	Elevated moisture reading below kickout.	2, 4.3
J 3 6	Downspout			Downspout fasteners need to be caulked.

Existing kickouts appear to be failing (elevated moisture found) and need to be modified. If kickouts were recently installed, the affected areas may not have had sufficient time to dry.
